# LOT 1, 2 AND 803 BALDIVIS ROAD, BALDIVIS

## REHABILITATION MANAGEMENT PLAN

Prepared for: Aigle Royal  
Report Date: 18 November 2024  
Version: 4  
Report No. 2024-833

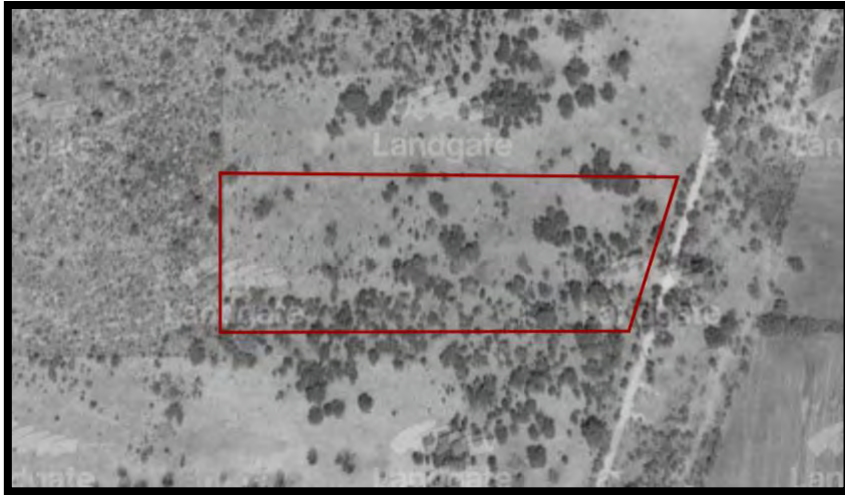
**Plate 1: Aerial Photograph from 1953 (Landgate, 2024).**

The site has had a history of clearing for rural activities as well as sand mining. In the earliest available historical aerial photography from 1953 the site appears to be cleared and parkland cleared with some remnant trees likely to be native (Plate 1).

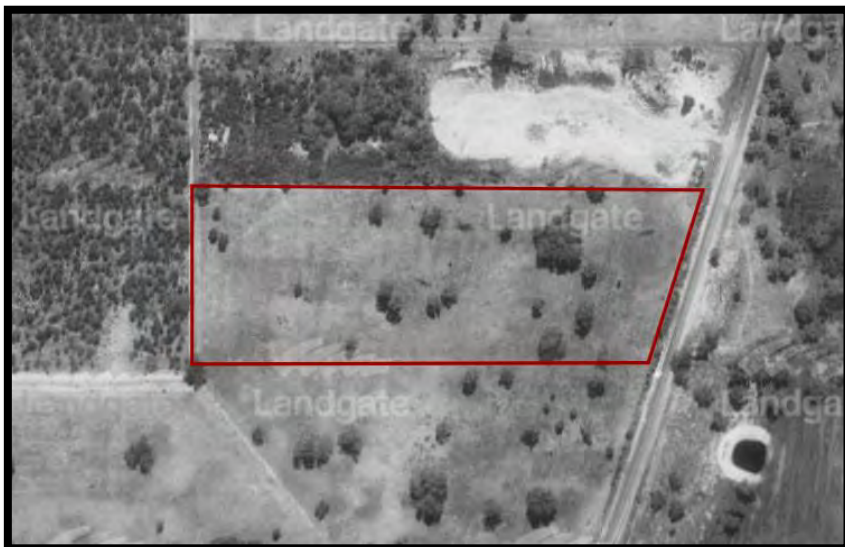
**Plate 2: Aerial Photograph from 1974 (Landgate, 2024).**

Between 1965 and 1974 (Plate 2) approximately half of Lot 1 was cleared and excavated for sand. The depth of excavation was approximately 10m. During this period Lot 2 and Lot 803 were largely cleared with a few scattered trees remaining (Plate 2).

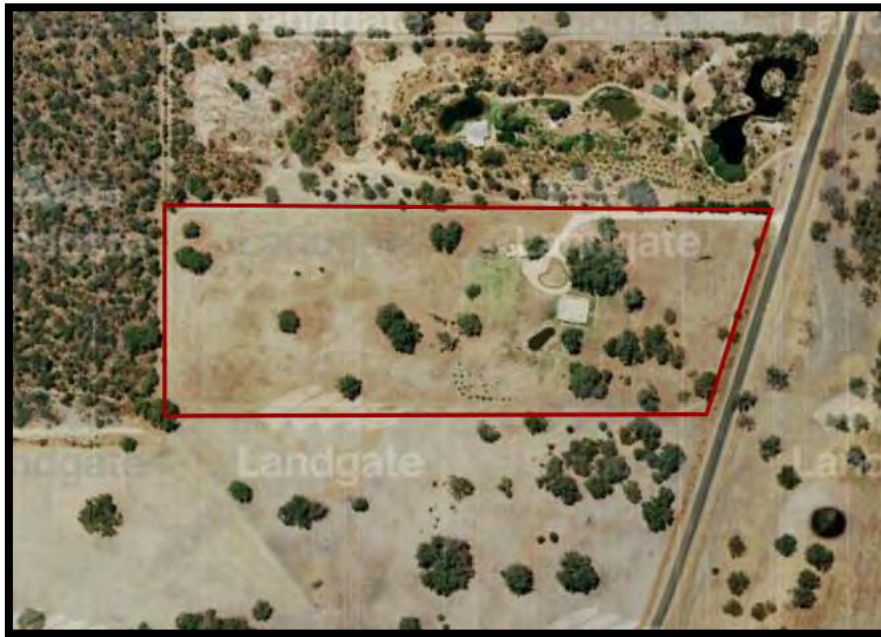
**Plate 3: Aerial Photograph from 1995 (Landgate, 2024).**

The clearing over 1 Baldivis Road was extended between 1985 and 1995 and dwellings were established on both lots (Plate 3). Lot 803 remained mostly cleared with some scattered trees.

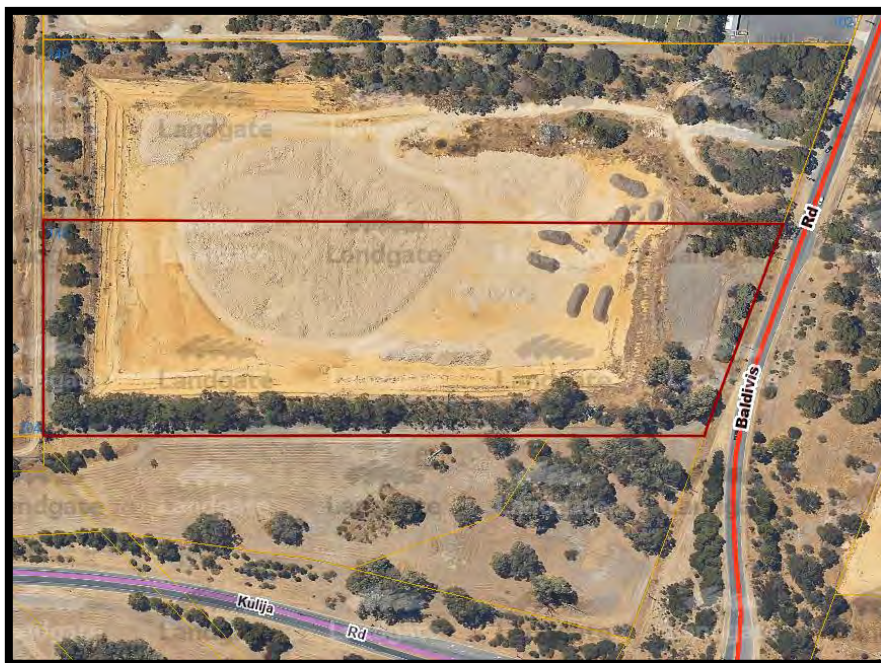
**Plate 4: Aerial Photograph from 2024 (Landgate, 2024).**

Sand extraction commenced on Lot 1 Baldivis road in 2017 and extended onto Lot 2. Plate 4 shows the current status of the site.
